Apex 360™ Memory

Case Study - Sub Surface Safety Valve Inspection

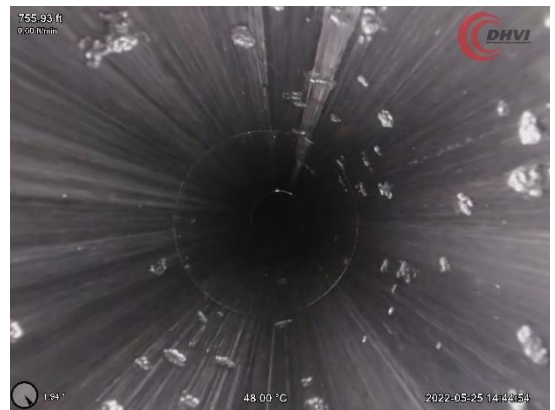
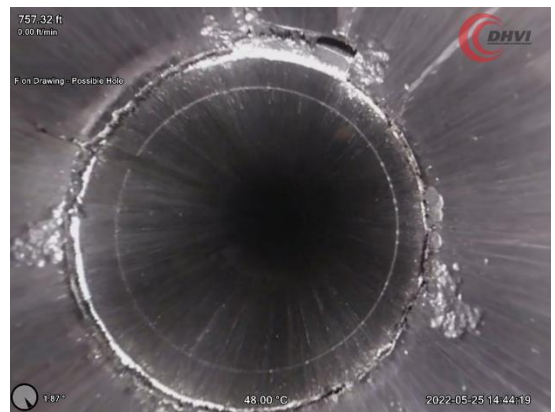
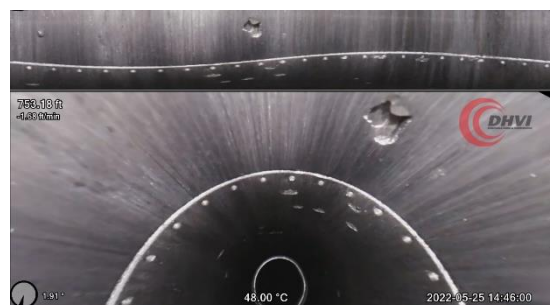
After locking out the safety valve, an initial drift run was performed to allow for safe and accurate deployment of the camera. The camera was deployed and positioned above the TRSSSV, where a series of logging passes were performed slowly through the interval. Detailed video was acquired through the full TRSSSV assembly which began to tell more of the story. It became apparent that there was significant corrosion present throughout in the form of pitting, and in some instances fully penetrated to form holes. The lock out sleeve was confirmed to be fully locked out and the flow tube was down, keeping the flapper valve in the fully open position, but also showed corrosion damage on the bottom shoulder.

The TRSSSV was fully mapped alongside the mechanical drawing. There was no clear indication of scale but extensive corrosion pitting which led to the suspected root cause. Side facing video helped to add perspective by gauging depth of penetration. The positioning of the holes now led to question the extent that the corrosion extended behind the lock out sleeve, flow tube and into other key components within the TRSSSV.
