# Capture™ Camera on E-Line

## Case Study - Sidetrack Re-Entry on Ghost Hole/Casing

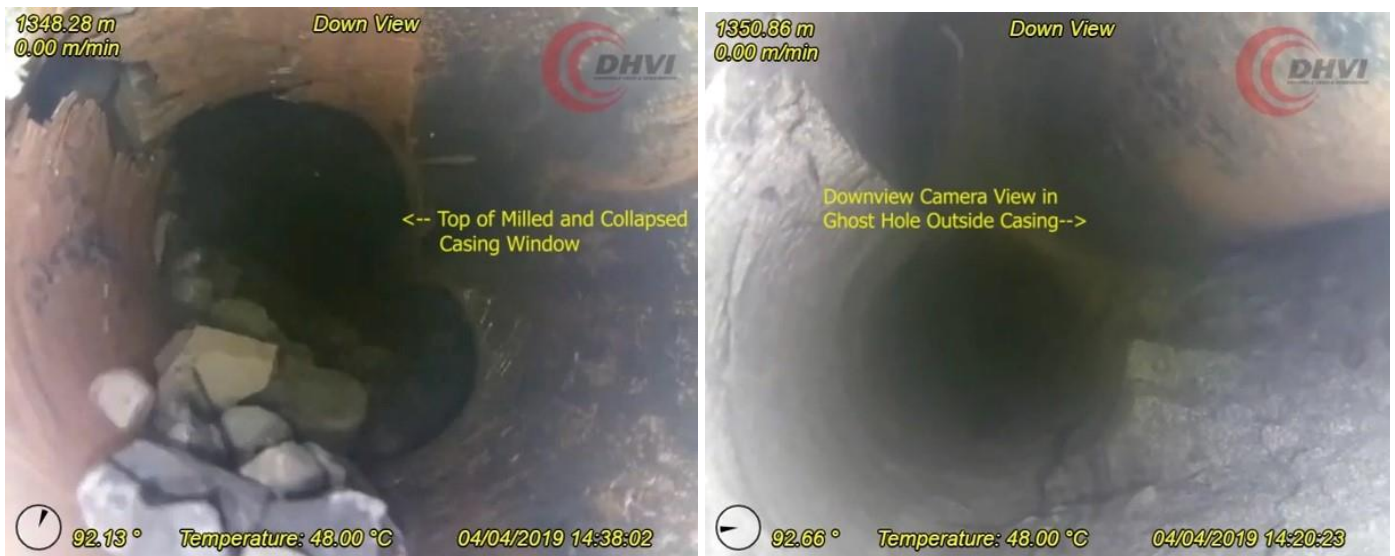
**Scope of interest:** As the camera reached the area of interest, the extent of the issue becomes apparent. The camera is able to verify that the casing was originally collapsed, and that the client had milled through the collapse into the open hole creating a Ghost Hole on the backside of the casing. The camera exited the casing revealing the extent of the Ghost Hole and with the sideview camera was able to verify the severity of the issue. The camera determined that both casing strings were parted and off to the side creating an alignment issue from the top to the bottom of the well. The client needed to re-enter the lower section to save the well and resume production but needed to find the top off the lower section to attempt.

The 360 rotating sideview camera was able to create a full image of the separation as well the client was able to formulate a plan with the fishing company. It was determined that the upper restriction would be milled out further and that a small spoon would be used to initiate time drilling into the lower section.

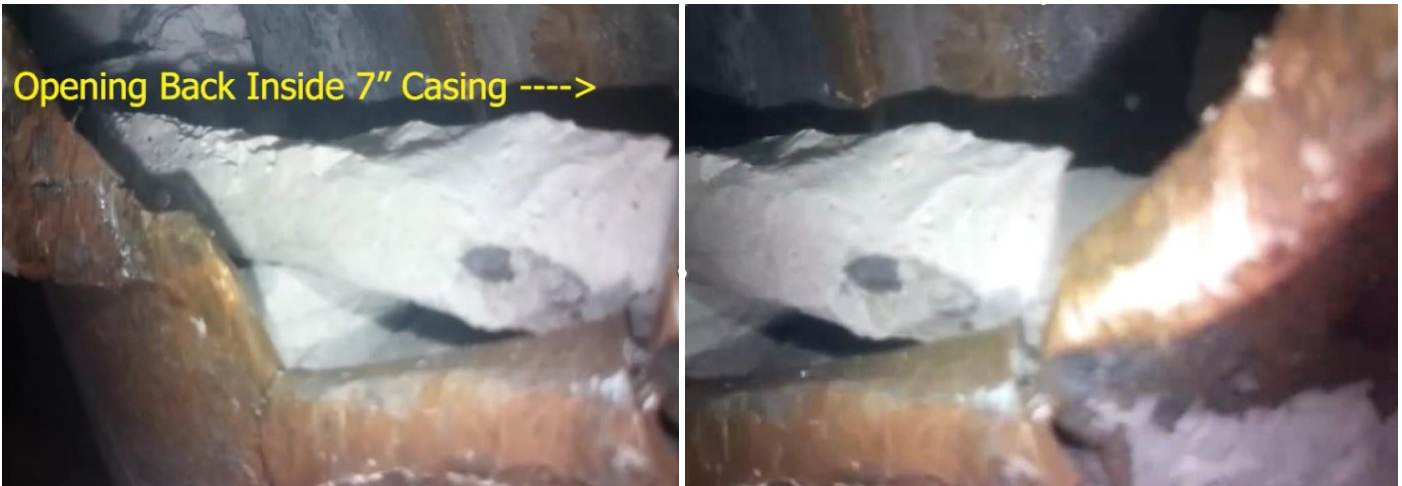
Sideview of the casing over the area of interest

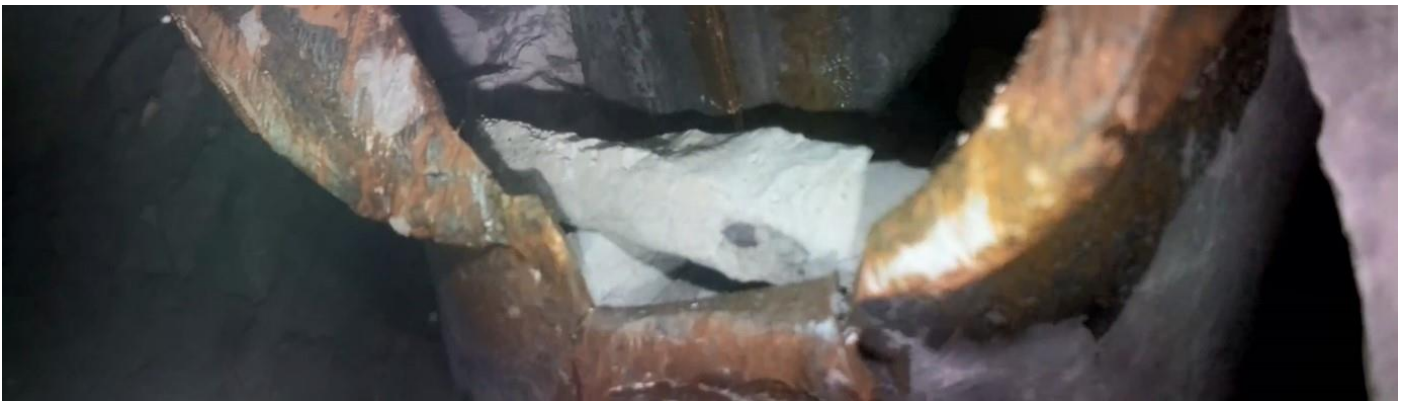
Panoramic sideview of the area of interest

**Conclusions:** The casing failure had occurred due to trapped pressure on the backside of the casing and when the flowback of the well occurred the reduced pressure inside created the perfect conditions to create the internal collapse. The client was not aware of the extent of the collapse and chose traditional methods as recommended by the service company to re-drift the existing wellbore. When milling the client encountered metal shavings and lost circulation thinking that they had gone through the impairment and were charging the open perforations. When they started to see formation returns to surface with the clean out on coil and the depths were not increasing dramatically they realized that they had an issue. With the camera the client was able to verify, formulate a plan with the fishing services, adapt the program and re-enter the wellbore below, saving the well and eliminate the outcome of abandoning the well!

The camera was used to verify and identify the progress of the sidetrack into the lower casing with multiple trips and the well was able to be re-entered after 3 days. The damaged area was patched, an isolation packer was utilized to isolate the damaged area and production was resumed within 7-8 days from the initial discovery of the casing failure.
